### Analysis on an AC Coupon

## Analysis on the Asset

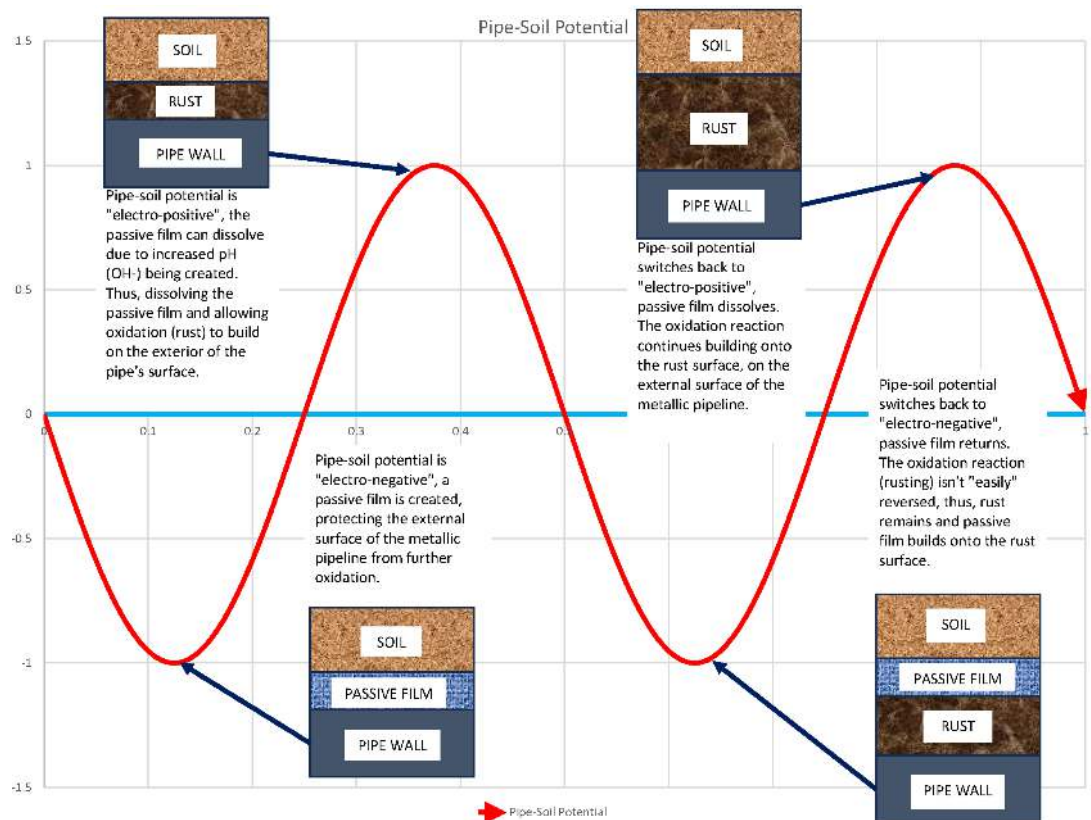
Referencing to *Figure 1*, below, "True" AC, in contrast to other forms of AC, changes direction relative to the signal's polarity. This means that the flow of electrons alternates back and forth, similar to a swinging pendulum. This constant change in direction is particularly harmful for localized pitting corrosion on metal surfaces buried in soil.

Figure 1: Example of a "true" AC sine wave.

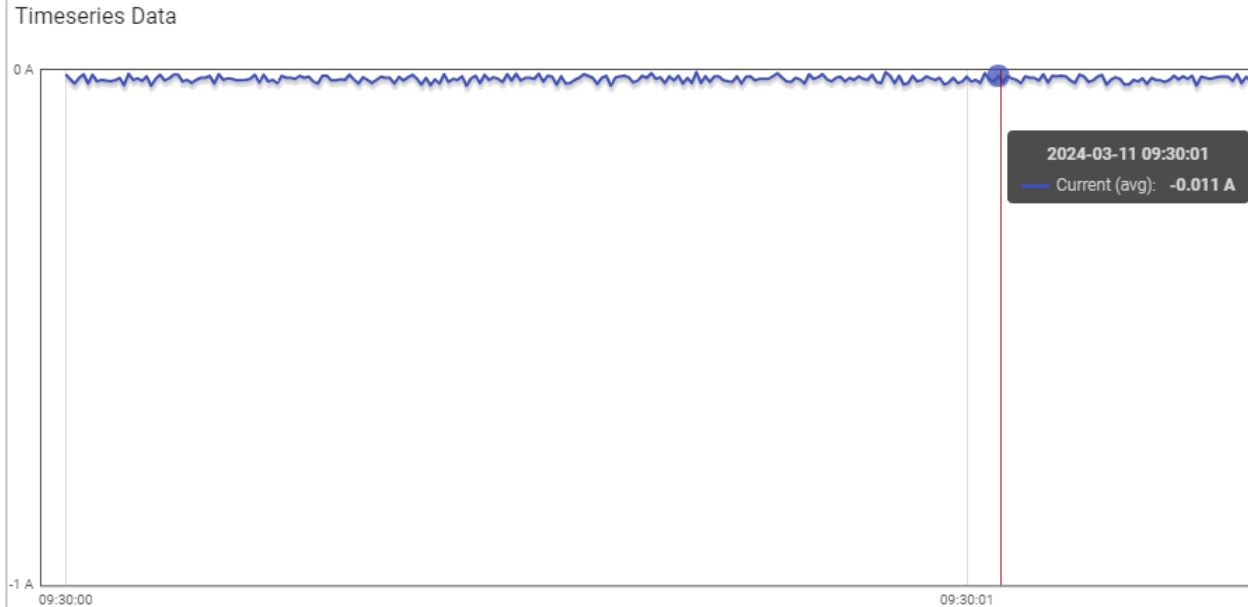
Figure 2: Current via AC Coupon

The current measured, shown in *Figure 2*, strongly presents that this current via the AC coupon is *not* of an AC source. Furthermore, through the signal analysis, as shown in *Figure 3* and *Figure 4*, there is hardly any fluctuation in the signal, with very little magnitude(s) of interest.

“IF” there is any AC on the line, it will have the frequency(s) shown in 4. But also keep in mind that the current polarity is not changing, as seen in the data log and *Figure 2*, thus, greatly reducing the concern of pitting corrosion.

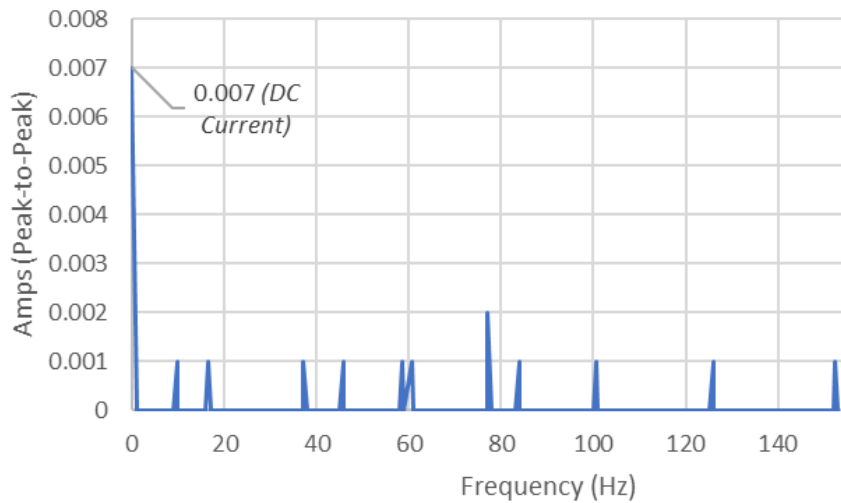
Figure 4: Graphed-AC Signal Analysis

This is the current which is being measured via a 1cm<sup>2</sup> AC coupon. With all this, we can confidently say, from this data, that the current at -0.007A and the coupon having an area of 1cm<sup>2</sup>, gives us a current density of 70A/m<sup>2</sup> (**DC**). Keep in mind that this is of a DC source, most likely from the source of cathodic protection.

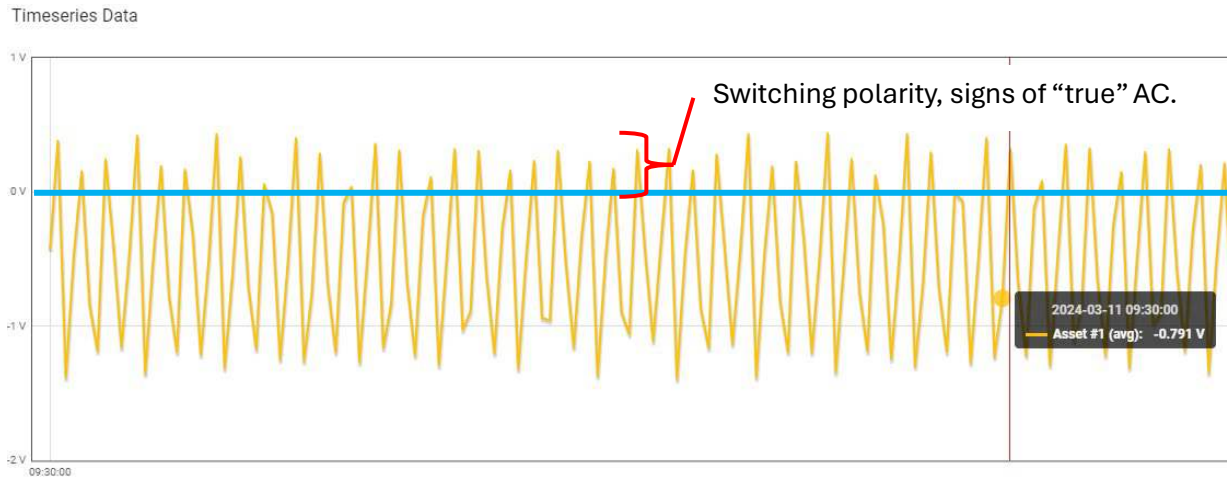
Figure 5: Asset #1 data log.

Looking at the potential of Asset #1, as shown in Figure 5, this is the asset’s potential with respect to a Zinc permanent reference electrode. Large fluctuations in the data log are seen. More importantly, the polarity is switching, as indicated by passing “0”, which is extremely detrimental in regard to pitting corrosion, as briefly explained on page 1. Furthermore, the signal analysis strongly suggests that there is AC present on Asset #1, as shown in Figure 6 and Figure 7.

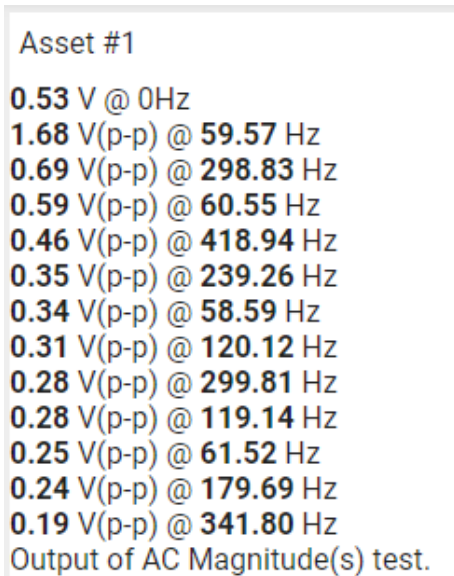
Figure 6: Asset #1 AC Signal Analysis

All in all, there is AC present on Asset #1 at coupon test station. Although, the data also suggests that the AC isn't coming onto the asset via the AC Coupon, rather, it’s already present on the line. A possible source could be from induced AC from HVAC lines near these asset(s) or from another direct connection/location.

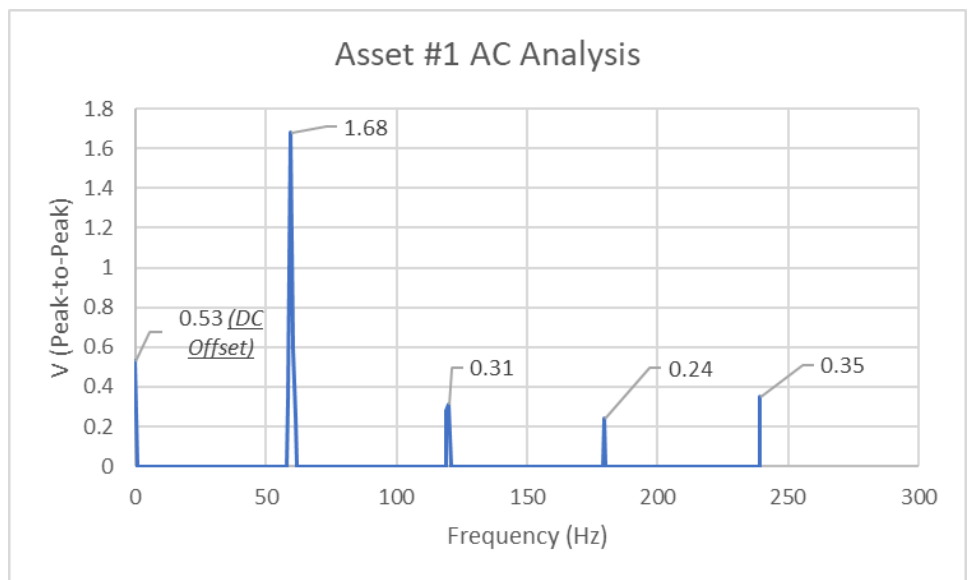
Figure 7: Graphed - Asset #1 AC Signal Analysis
