Iso-Smart Field Evaluation and Case Study Report

Test Site: BETA, Coupon Test Station #18

Prepared by: Gabriel Gonzales, Sr. R&D Engineer

Date: June 2025

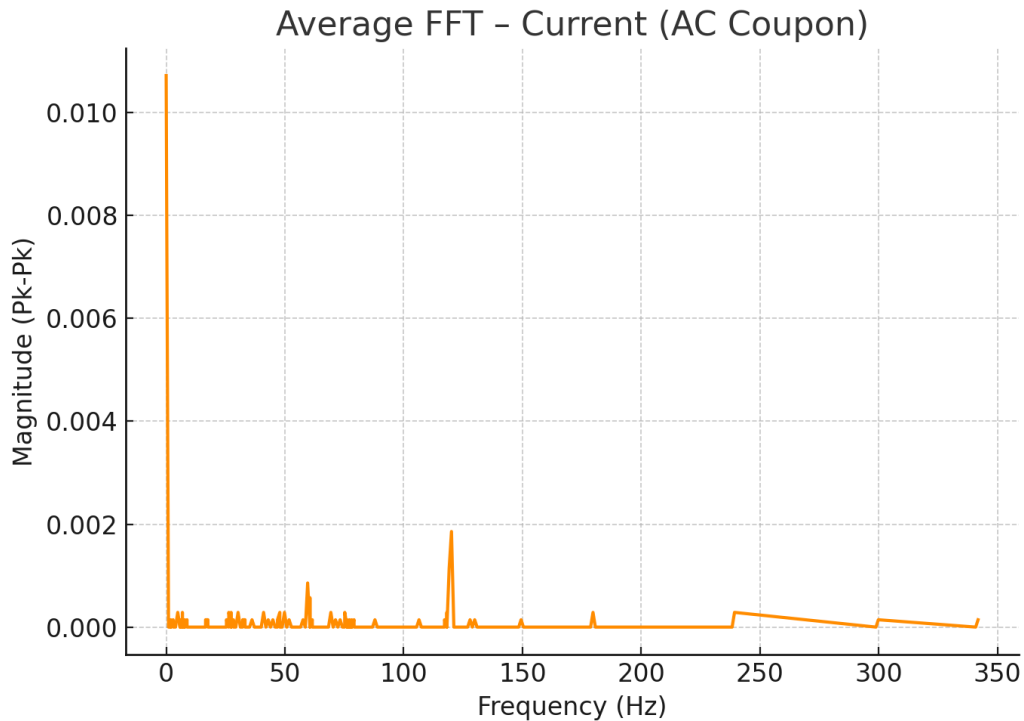
The measured DC current through the coupon was approximately -0.012 A , resulting in a current density of $\sim 120\text{ A/m}^2$. No polarity reversal was observed in the current waveform. FFT analysis of the current signal showed a dominant DC component with negligible higher-frequency contributions.

Conclusion: Current is DC-dominant, likely originating from the CP system. No indicators of "true" AC were observed at the coupon.

- Strong DC peak.
- No significant harmonic activity.
- Low-magnitude and flat across frequency spectrum.

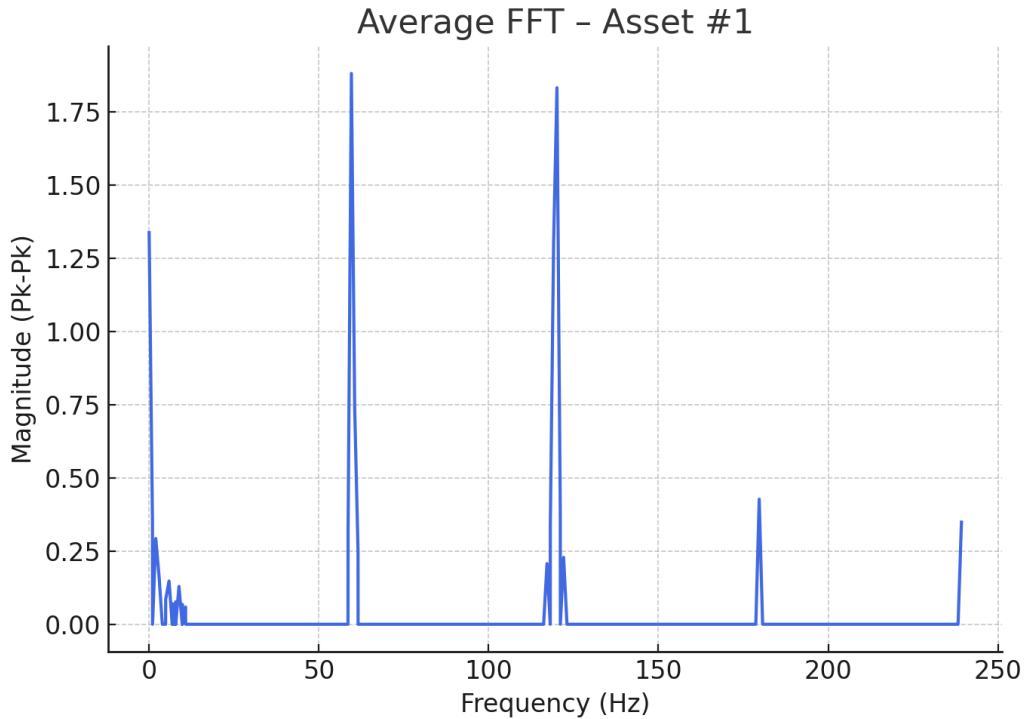
Voltage relative to the zinc reference electrode ranged from -1.6 V to -1.8 V , indicating effective CP protection. However, polarity shifts in potential were noted during some periods. FFT analysis revealed peaks in the $58\text{--}62\text{ Hz}$ range, characteristic of AC interference, likely induced from nearby HVAC or utility sources.

Conclusion: AC presence was confirmed on the pipeline, but not introduced through the AC coupon. Rather, it likely originates from external induction or rectifier ripple.

- Dominant frequency content in the 60 Hz region.
- Additional frequency signatures may correspond to 120 Hz ripple from full-wave rectifiers.

Interpretation: The Iso-Smart's sensitivity allows it to capture small oscillations potentially tied to unfiltered rectifier outputs. These are not necessarily "true" AC, but may appear in the frequency domain due to high-resolution sampling.
