## A New Option to Traditional Plastic Isolation Gaskets

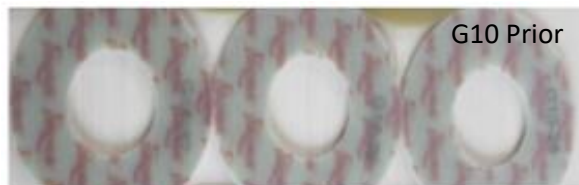
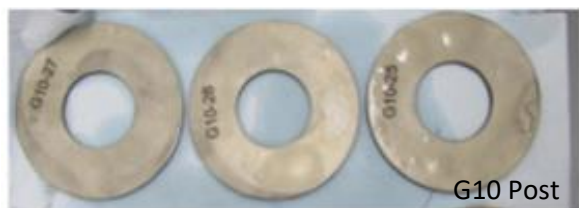
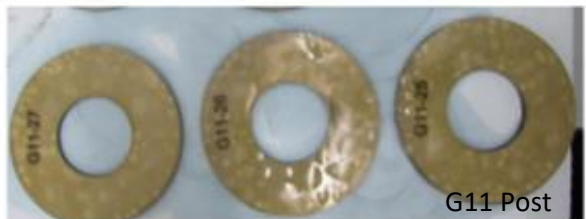
The world's oil and gas is becoming more and more sour. As we drill deeper and farther than ever before, we are encountering higher percentages of  $H_2S$  than we had seen in the past. This has significant effect on isolation gaskets. Below is a test performed at Amtec test laboratories. It is a fourteen day exposure at  $150^{\circ}C$ , 2000psi in a mixture of 18/71/11 mol %  $H_2S/CH_4/CO_2$ . As you can see from the images, both G10 and G11 are significantly attacked by this mixture. G10 is a glass reinforced epoxy rated to  $150^{\circ}C$  and G11 is a glass reinforced epoxy (GRE) rated to  $200^{\circ}C$ .

As you can see, both the G10 and G11 had a significant amount of bubbling on the surface of the gasket samples. Density, mass and volume were all tested before and after the test as indicators for chemical attack. Both the G10 and G11 had major shifts in all three areas (see graph below):

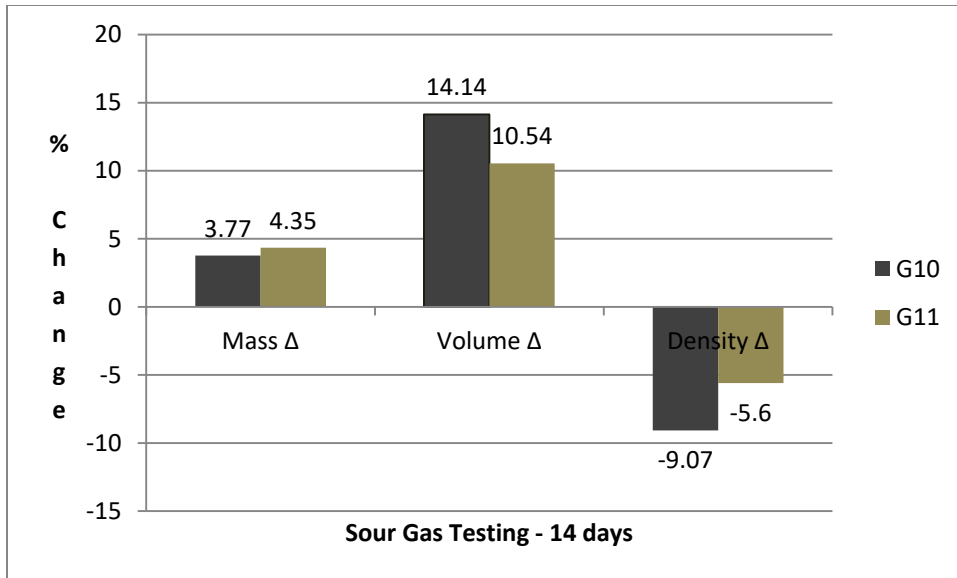
Changes of this magnitude in a 14 day period indicate chemical attack of the material. An isolating gasket that loses density and gains volume is more likely to blow out at high pressures.

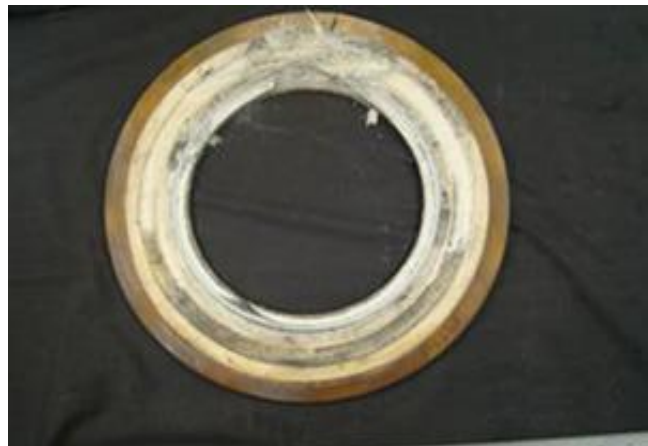
Steam can be as much an issue with GRE (both G10 and G11) as sour gas. This was a G11 isolation gasket after 34 weeks in steam/carbonic acid service. The epoxy in the GRE is compatible with carbonic acid so the carbonic acid wasn't the issue, but it is not compatible with steam as can be seen from this image. G11 is rated for 392F/200C, so the 270F is not the cause of failure. Steam causes hydrolysis in the epoxy and this dramatically softens the laminate. With softening of the gasket and volume loss, blowout is a real danger.

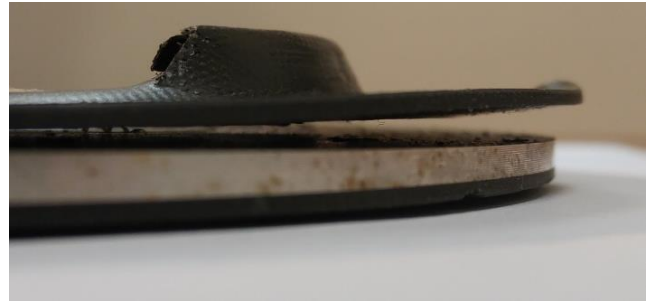
To the right is an image of a G10 based plastic isolation gasket that was installed in a hydrocarbon application and subsequently blew out. Gaskets had been in operating service up to 1,100psi and 260°F/127°C for a period of one year. Analysis indicated bubbling of the epoxy in spots and delamination from the 316SS substrate. Temperature exposure at or above the glass transition temperature reduces the mechanical strength of the G10 or G11. High temperature, coupled with improper installation techniques or high pressures, can cause joint blowout.

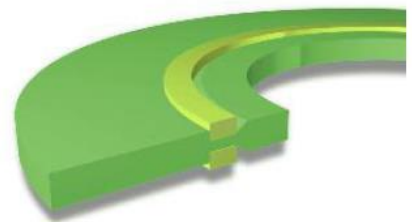
The pressure of the media permeates through the GRE, then contacts the angle in the groove and is forced at an upward angle. The force then pushes the seal against the flange face creating a tighter seal. This works well for surface leakage,

however media that permeated into the body of the gasket is able to potentially permeate from the inside diameter (ID) of the gasket to the outside diameter (OD) of the gasket causing emissions or visible leakage. Many users that use soapy water on the outside diameter of their plastic isolating gaskets have found bubbles forming from just this reason.

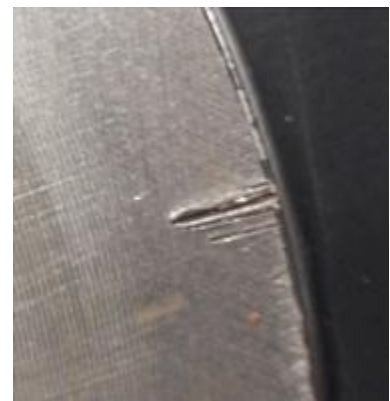
We discussed the permeation of GRE of gases, but water can also permeate if pressurized. To test this, a test was conducted at ambient temperature (74°F/23°C). Water was pressurized to 5,575 psig(383 Barg). The gasket was exposed to the pressure for a minimum of 10 minutes. The gasket was tested pre-hydrotest and post hydrotest for electrical resistivity and was evaluated for pressure drop during the test. To make the test even more difficult, a gouge was put in the face of the flange to insure the gasket could seal and isolate a flange that was in "less than ideal" conditions. Less than 278 psig(19 Barg) loss (5%) was deemed acceptable during the test. In actual results, the gasket lost an average of 102.5 psig (7 Barg) over multiple tests.

Resistivity results were >10 Gohm at 50 Vdc and an average of 40 Gohm at 1,000 Vdc indicating that this isolating gasket can be hydrotested and still maintain significant electrical resistance. The same cannot be said for plastic GRE type gaskets. A similar hydrotest evaluation was done with metal cored, plastic GRE isolation gaskets and the resulting resistivity results were an average of only 4.77Mohm at 1,000 Vdc....a 10,000 times improvement!
