# Case Study: Compressor Station

## The Multiple Failures of Phenolic Gaskets

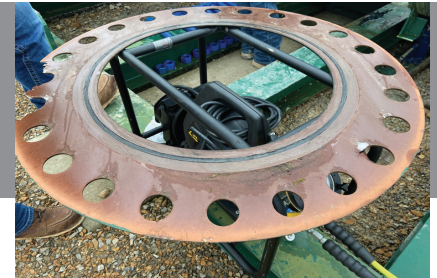
The Cathodic Protection (CP) team identified that a year after installation, which was challenging due to issues with gaskets cracking, that the isolation gaskets were not isolating. On closer inspection, it was established that bridging issues due to conductive media (Iron Sulphide) was the route cause for the electrical isolation failures. In addition, the CP team noticed that the gasket was leaking from within the gasket itself – the media was permeating through the body of the gasket.

Phenolic isolation gasket removed from flange

We introduced EVOLUTION<sup>®</sup> to the operator, it was clear that the benefits and design EVOLUTION provides would address all the issues encountered, with the added value of being a Fire Safe gasket.

EVOLUTION<sup>®</sup> is designed with a GYLON<sup>®</sup> inside diameter seal, which provides resistant to typical oil and gas chemicals including Iron Sulphide (FeS). The unique properties of the GYLON seal do not allow for particles to build up on the seal, which is one of the causes of electrical bridging. GPT worked with the client to ensure the seals matched the pipe bores, another significant factor which contributes to electrical bridging. All GPT isolation kits are matched to the pipe bore as standard.
