THE EFFECTS OF OPERATING A PIPELINE **WITHOUT** ISOLATION

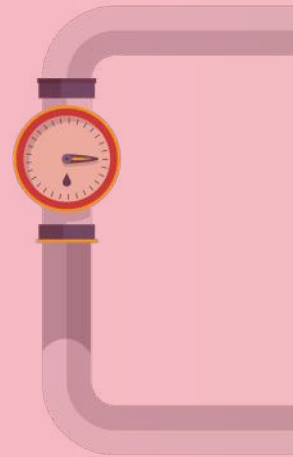
As the defect gets larger, the current flow increases and more of the coating is pushed away from the metal. Both oxygen reduction and hydrogen evolution are possible cathodic reactions that will increase the pH at the cathode. This can result in rapid disbondment and coating breakdown. Several more factors such as concentration of stray current, ground water chemistry, CP level, oil chemistry, surface roughness, surface contamination, pipe bending, and the presence of defects can significantly affect adhesion.

Corrosion under coating disbondment is an undesirable phenomenon which is difficult to detect using conventional above ground techniques. Due to the presence of electric current in a CP system, if a coating is not stable in the CP environment, a highly alkaline environment coupled with the polarized potential can cause coating to lose adhesion and dis-bond from the substrate. Coating disbondment occurs when all adhesive forces have been lost locally. It is recognized that the adhesion property of a coating is a key determinant in the long-term ability of a coating to protect the substrate. The presence of a small pinhole can lead to cathodic reaction at the holiday in the coating which then stresses the disbondment of coating from around the edges of the holiday. The mechanism of cathodic disbonding is a debated subject but it is generally agreed that the cathodic reaction at the holiday site in the tested coating forms an alkaline (high pH) water film under the coating that causes the disbonding. The amount of such a corrosion is determined by the amount of current available and the size of the coating defect. Also there seems to be some connection to the fact that adhesion between the coating and the steel surface is affected by the high pH factor evolving due to the CP on areas where bare steel is exposed to such electrolyte. Studies have revealed that in the presence of CP, the pH inside a crevice increases with time. If enough time is allowed, the pH factor in the crevice become higher than a holiday. Likewise, an O₂ (g) concentration cell can form in the crevice, which in turn determines corrosion rates. The ionic current generated by the differential O₂(g) content along the crevice results in a deeper penetration and, therefore, in a more severe corrosion activity.
