Ian Kinnear, Product Manager, GPT Industries, addresses the impacts of hydrogen sulphide, particularly on corrosion and electrical bridging, and provides solutions to these challenges.

THE SOURING

OF PIPELINES

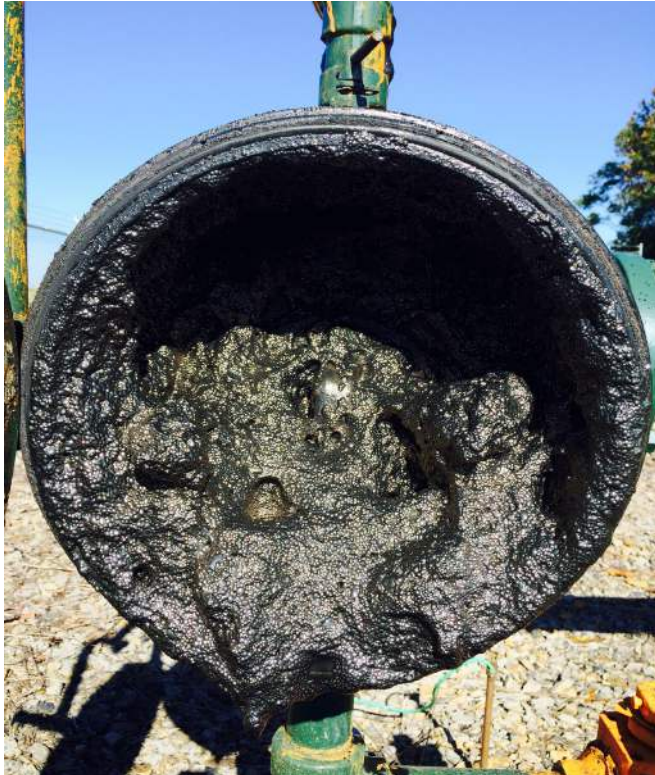
Figure 1. An extreme case of iron sulphide or better known as black powder, build up inside of a pipeline.

Iron sulphide, known in industry as black powder, readily precipitates from H₂S-tainted condensate within pipelines. Over time, iron sulphide deposition can completely mask isolation joint gaskets. Its extreme conductivity enables sustained electrical connectivity between flanges, bypassing the isolation joint's function. The iron sulphide sludge apparent in Figure 1 illustrates the severity this bridging phenomenon can attain.

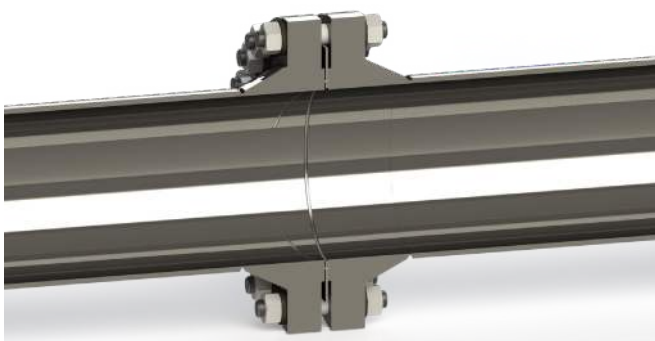
Figure 3. The flange connection, where electrical bridging can take place if built up occurs.

Electrical bridging occurs when an electrically conductive material, often iron sulphide corrosion products, spans the isolation joint to create a current pathway between pipe segments. This provides an easier path for CP current to flow than the intended circuit through the soil back to the rectifier. When bridging happens, CP systems continue pushing current through now-connected sections rather than forcing it to disperse into the ground. This can often be seen by what are called travelling shorts. Travelling shorts occur as a pipeline cleaning pig goes down the line and deposits this iron sulphide at the flange interfaces. When this occurs, you will see a shorts travel down the line as the pig does, being isolated before but potentially no longer after.
