Iso-Smart Field Evaluation and Case Study Report

Test Site: BETA, Coupon Test Station #18

Prepared by: Gabriel Gonzales, Sr. R&D Engineer

Date: June 2025

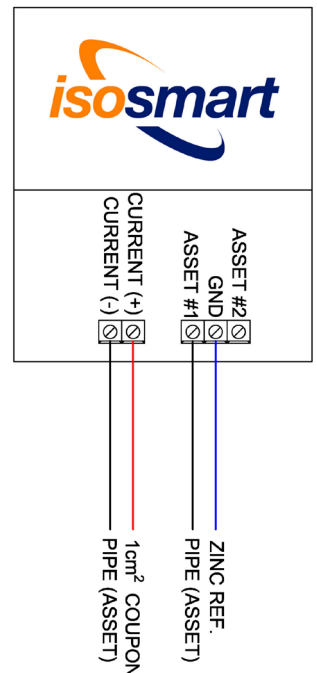
Figure 1: Iso-Smart Connections

- **Cathodic Protection Monitoring:** Asset #1 input was connected to the pipeline, referenced to a permanent zinc electrode. See **Figure 1**.
- **Current Monitoring:** The current was measured between the pipeline and a 1 cm² AC coupon. The pipeline was connected to the negative terminal of Iso-Smart's current sensing circuit, and the coupon to the positive terminal. See **Figure 1**.
- **Rectifier Details:** Full-wave rectifiers provide CP to the pipeline. These generate a 120 Hz signal. Some rectifiers may include output filters (e.g., smoothing capacitors), while others may not, resulting in potential ripple on the output voltage. See **Figure 2**.

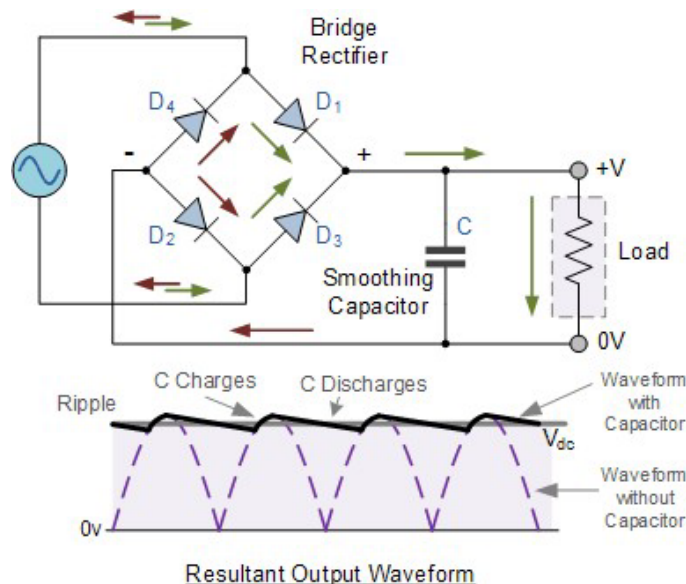
Figure 2: Smoothed, Full-Wave Rectifier

The Iso-Smart system, known for its high sensitivity and resolution, is capable of detecting frequency components even from semi-filtered full-wave rectifier output.
